Manhole Inspection Summary

Manhole # S41G__040MH

Insp Date: **5/19/08 9:45 AM**

Location Address: **227 s central**

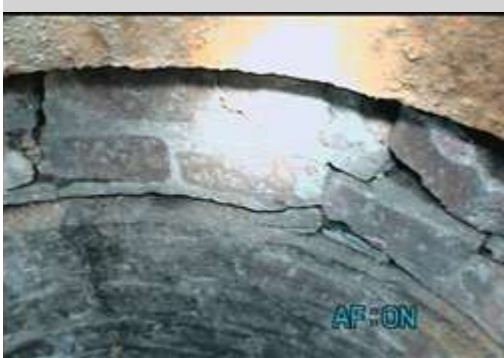
Defect 2

Condition: ☐ Sound ☒ **Cracked** ☐ Root Intrusion ☒ **Loose Brick** ☐ Deteriorated

chimney cracked & loose bricks

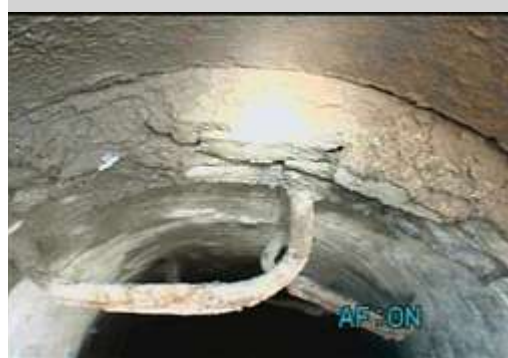
Defect 1

Frame Offset: **2** (in.) Condition: ☒ Sound ☐ Cracked ☐ Leaks

Infiltration: ☐ None ☒ **Joint** ☐ Cracks ☐ Mortar ☐ Roots ☐ Wall

frame offset, chimney infiltration from joint

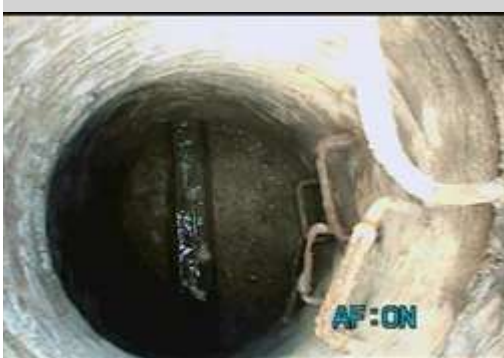
Defect 3

Condition: ☐ Sound ☐ Cracked ☐ Root Intrusion ☐ Deteriorated ☐ Leaks ☒ **Debris**

Steps Count: **6** Missing: **0** ☒ **Corroded**

corroded steps, bench debris

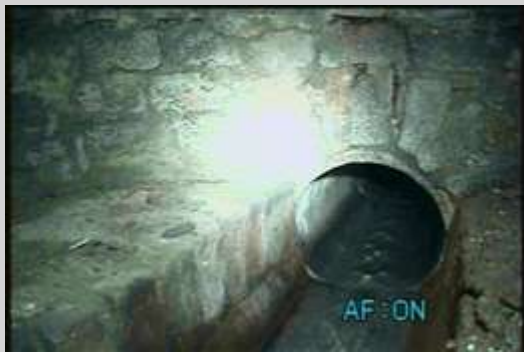
12 O'Clock Outflow

8 in. Circular Gravity Sewer
Pipe Out @ 12 O'Clock

Invert Depth: **9.29** (ft.) Flow Characteristics: **Slow**

Infiltration: **None** Pipe Seal Cond: **Unknown**

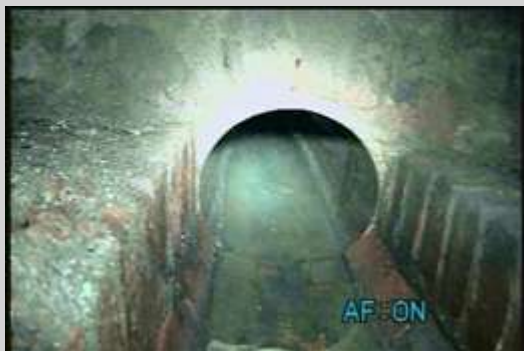
6 O'Clock Inflow

12 in. Circular Gravity Sewer
Pipe In @ 6 O'Clock

Invert Depth: **9.18** (ft.) Flow Characteristics: **Slow**

Infiltration: **None** Pipe Seal Cond: **Unknown**
